TECHNICAL INFORMATION SHEET

PART NUMBERS: **1428 / 1432 / 1544 / 1555 / 1556 / 1557**

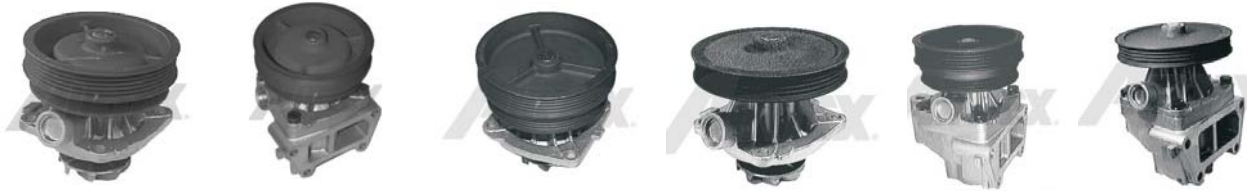
1428
The same as 1432
without cover

1432

1544
The same as 1556
without cover

1555
The same as 1557
Without cover

1556

1557

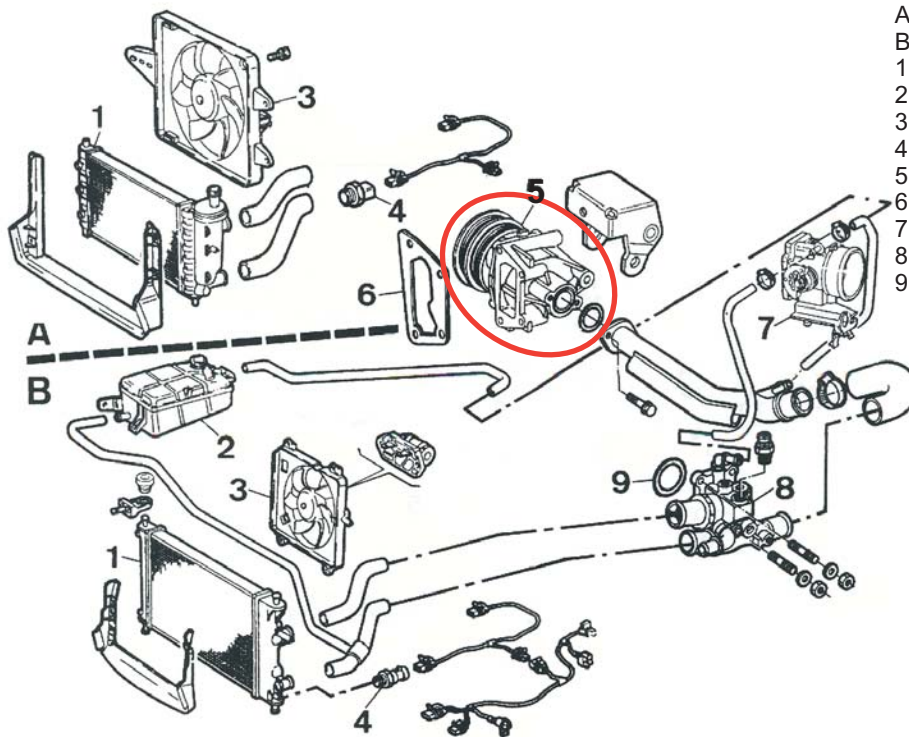
Example of a cooling system from a Fiat Bravo - Brava 1.6 Gasoline (PN. 1556)

- A. Without air conditioning
- B. With air conditioning
- 1. Radiator
- 2. Expansion jar
- 3. Fan engine
- 4. Temperature switch
- 5. **Water pump**
- 6. Water pump gasket
- 7. Throttle cover
- 8. Thermostat housing
- 9. O'ring

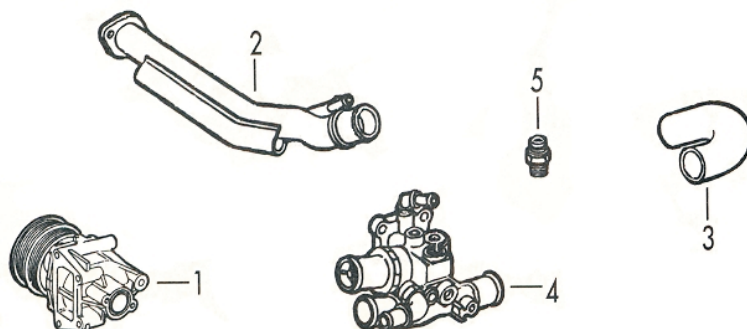
Water pump from a Lancia Delta '93 1.6

- 1. **Water pump**
- 2. Outlet pipe
- 3. Hose to thermostat
- 4. Water pump cover with thermostat
- 5. Temperature gauge

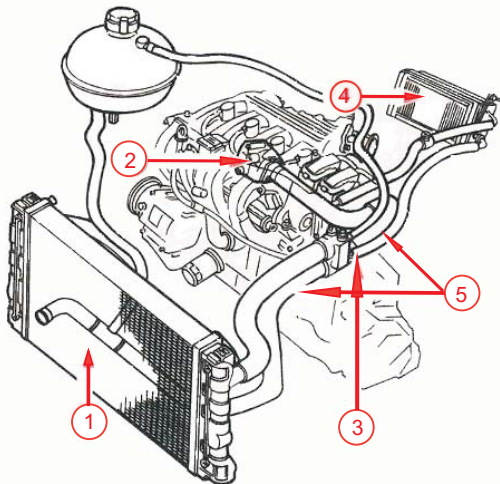
→ Cooling system

1. Cooling radiator
2. Circulating pump
3. Thermostat
4. Radiador habitáculo
5. Connection hoses

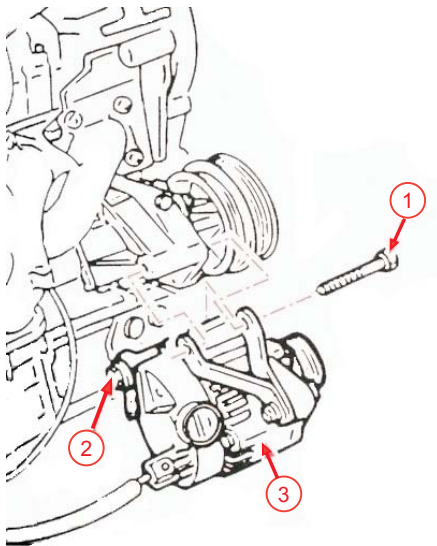
→ Demounting of the water pump

- Remove the alternator/pump belt.
1. Remove upper lock bolt (1)
 2. Unscrew the internal lock bolt
 3. Rotate the alternator down to accede to the water pump.

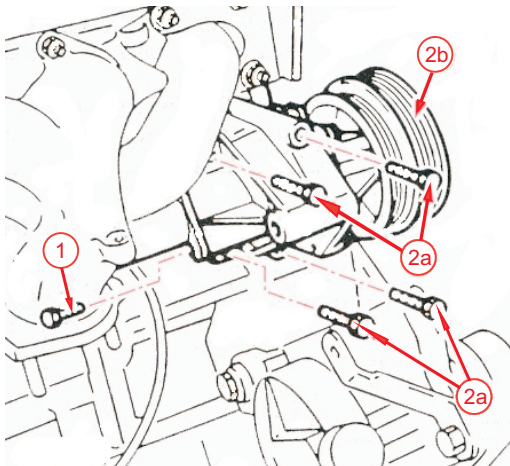
1. Remove the fixing bolts (1) of the inlet pipe in the water pump, from the water pump side.
2. Remove bolts (2a) and the water pump (2b) with support.

Torque: 2,1 - 2,6 daN.m
